# Recreating the CRaTER SN01 (FM2) D2 Anomaly with the Engineering Model

*Tony Case and Mike Golightly*  
*2007-11-13*

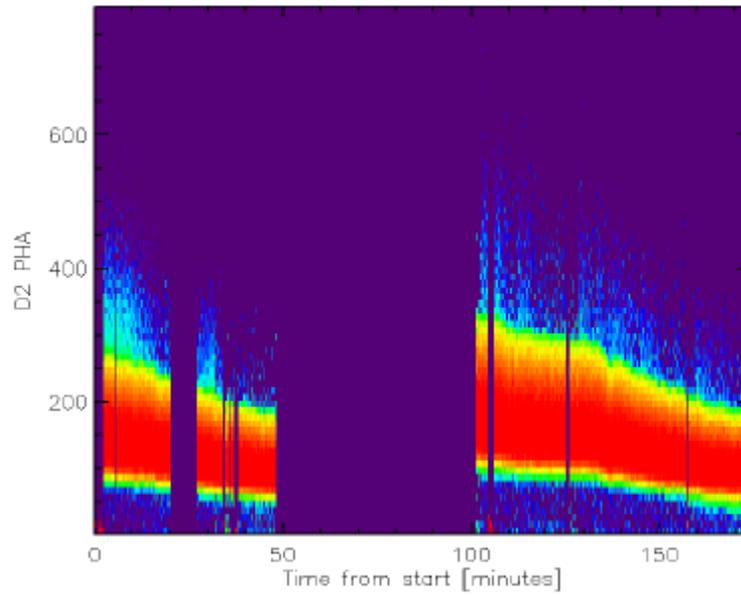
There were two main manifestations of the issue. Firstly, there was an apparent decrease in the gain of D2. The magnitude of the decrease in gain also appeared to change as a function of time (See Figure 1). The change in gain did not appear in pulser data. Secondly, the D2 singles rates showed extremely high count levels with the detector bias on, but much lower count rates with the bias off.

**FIGURE 1:** 2-D histogram showing the pulse height of D2 vs. time during a proton beam run at MGH. The peak deposit in D2 is expected to be in approx. 500-600 ADU, but appears around 300. It is also seen that the apparent gain of D2 changes over time. Data gaps occur when data was not being acquired.

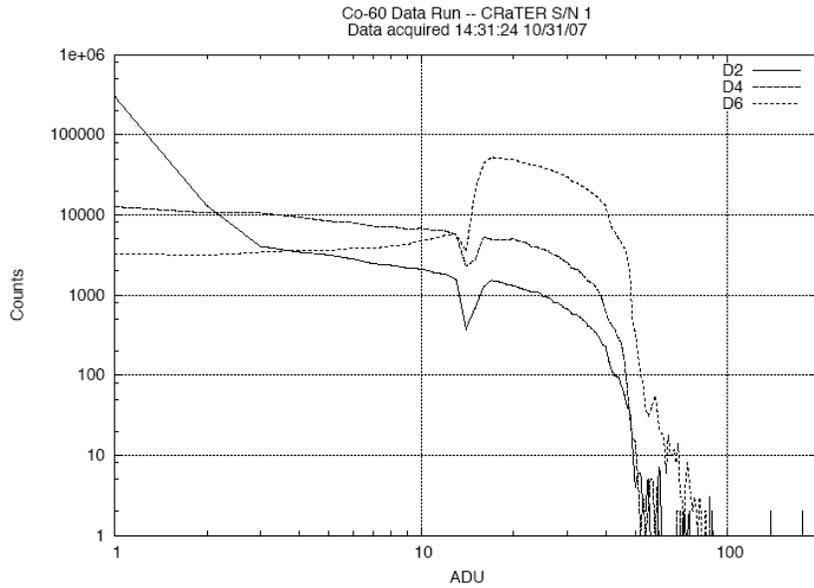
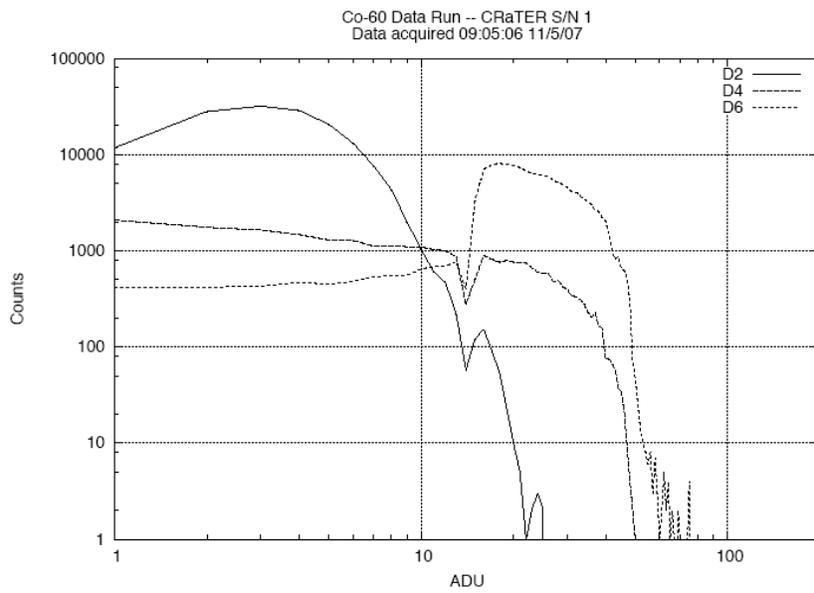
The instrument was then returned to MIT, where the problem was seen using a Co-60 source (See Figure 2), and persisted for approximately a day before apparently resolving itself.

**FIGURE 2: Top Panel:** Co-60 run from Bob Goeke prior to the appearance of the anomaly. All detectors look similar (except for count rate, due to source location).

**Bottom Panel:** Co-60 from Bob Goeke after the MGH run. The apparent change in gain is clear in D2.

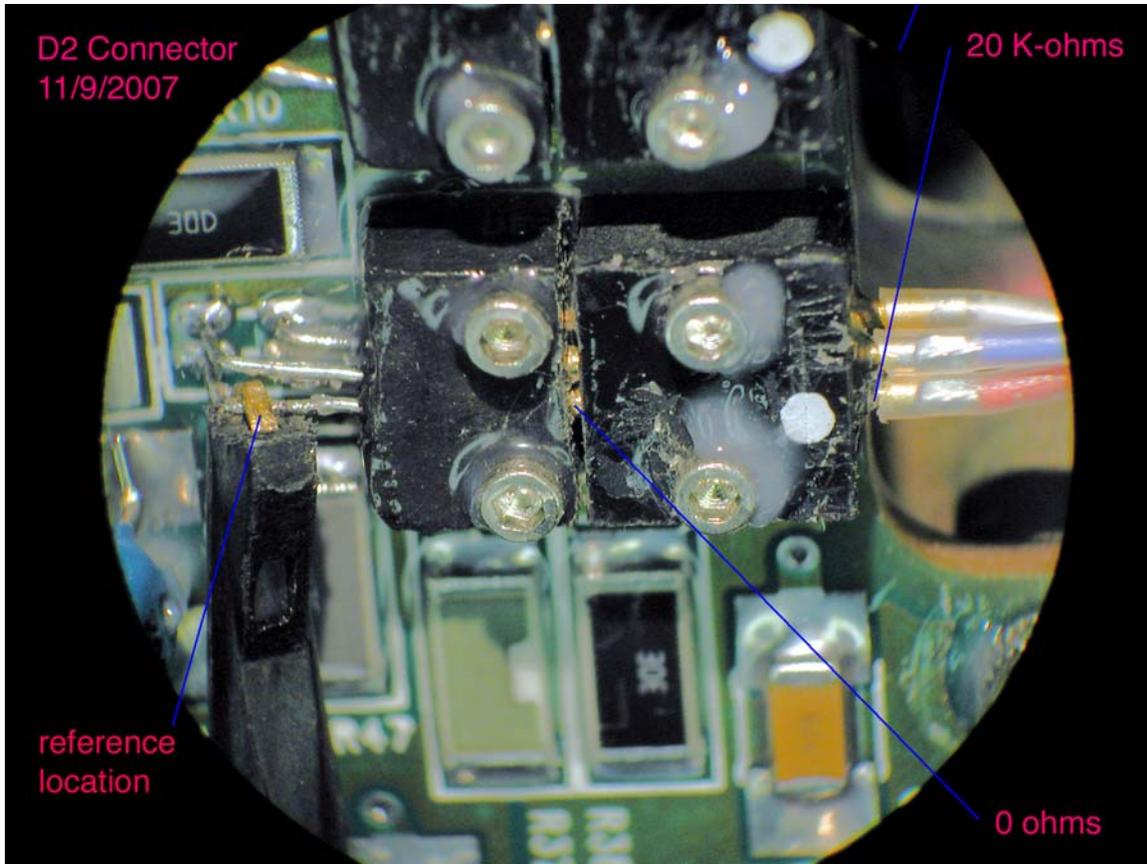
On November 8<sup>th</sup>, troubleshooting commenced with Bill Crain from Aerospace and the MIT engineering crew (Jimmy, Dorothy, Bob, Matt, Rick) present at MIT. It was found that there was a resistance across the connector where D2 attached to the telescope board causing the detector to not be fully biased (See Image 1).

Upon further investigation, it was discovered that conformal coating had found its way into the D2 connector and was causing the observed drop in voltage across the connector (See image 1). The telescope board was removed and taken back to Aerospace with Bill so that the board-side connector could be replaced, while the rest of the telescope remained at MIT for further inspection.

The presence of conformal coat in the D2 HV bias line connector on CRaTER FM2 (SN01) appeared to cause a resistance across the connector of  $\sim 25$  k $\Omega$ . Testing done on the engineering model indicates that a resistance of that magnitude can cause changes in the apparent gain and singles rates that are consistent with the anomaly observed in the flight model at MGH and MIT.

**IMAGE 1:** Microphotograph of the FM2 (SN01) D2 connector on the telescope board. It was found that there was conformal coat in the connector causing the observed resistance across the connector.

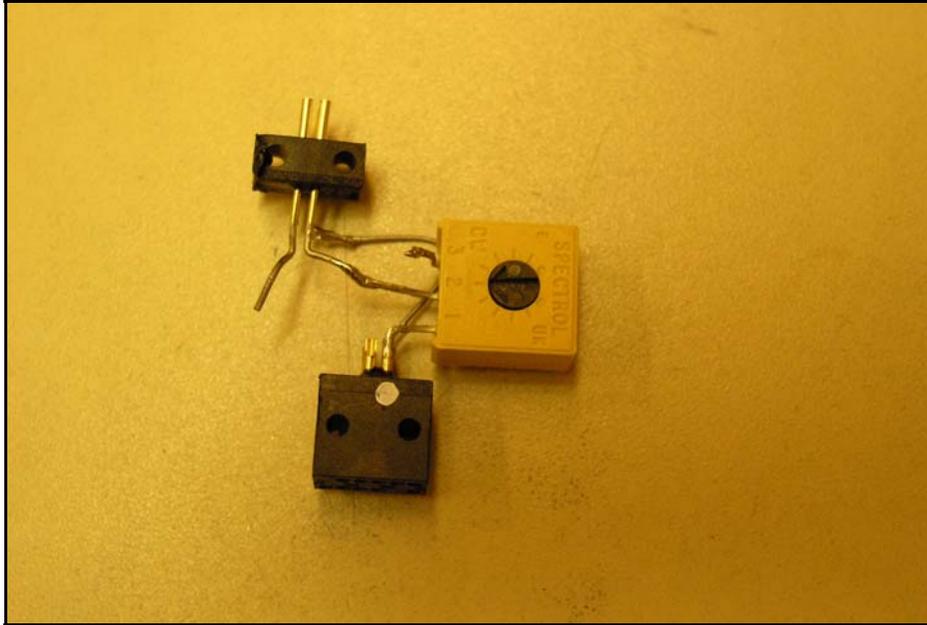
**IMAGE 2:** A connector designed to simulate the resistance caused by conformal coat in the HV bias line. It was formed from spare connector parts and a potentiometer.

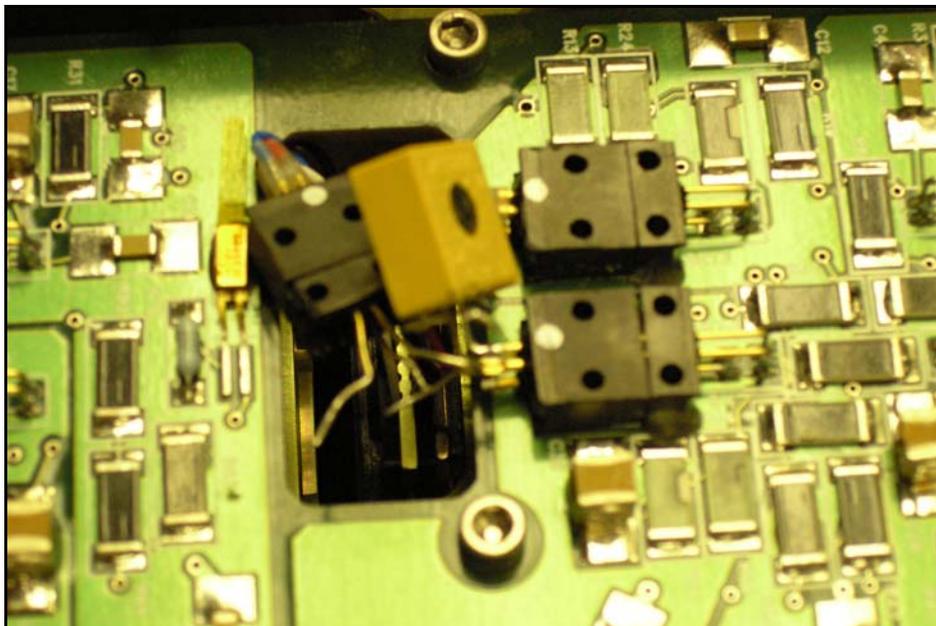
**IMAGE 3:** The connector installed on D4 of the engineering model.

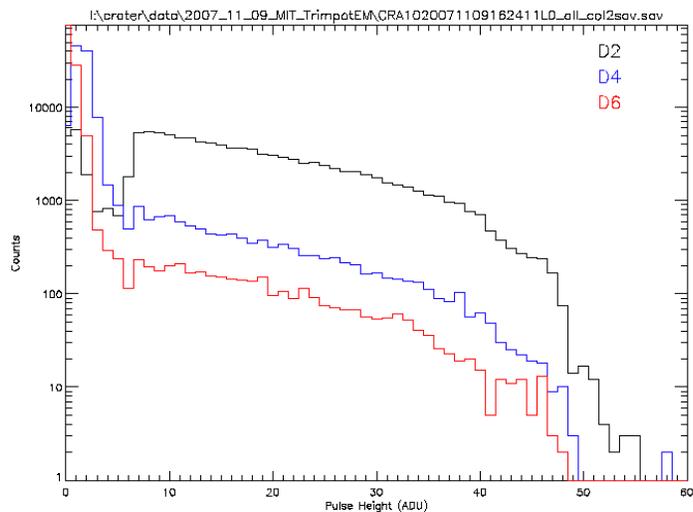
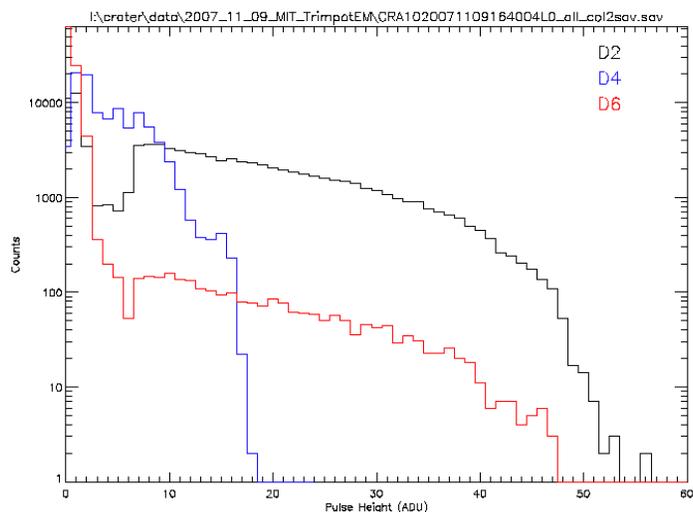
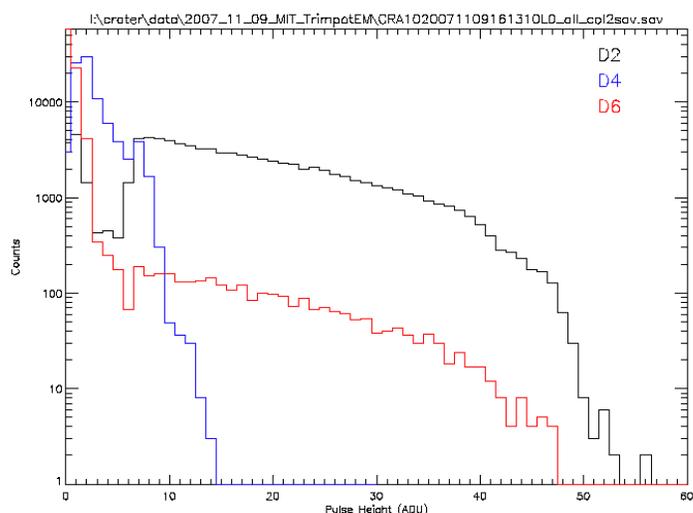
It was noticed that there was interference from a light leak which was promptly fixed. Data were acquired at 0, 23.3k $\Omega$  and 50k $\Omega$  and it was found that non-zero resistances across the connector caused a considerable decrease in the apparent gain of D4. The decrease was consistent with observations of the anomaly from the flight model at MGH and MIT (See Figure 4). At the higher resistance, the apparent decrease in gain was more pronounced.

**FIGURE 4:** Thick detector histograms with potentiometer in-line on detector 4 of the EM. A Co-60 source is present on the zenith (D2) side of the telescope.

Nominally, all the detectors would have similar shapes (though count rates will differ since the source is at one end). This is seen in the top panel (no resistance across connector), but when a resistance is introduced (middle and bottom panels), the apparent gain of D4 changes.

**Top Panel:**  
Potentiometer set to 0.

**Middle Panel:**  
Potentiometer set to 23.3kΩ

**Bottom Panel:**  
Potentiometer set to 50 kΩ

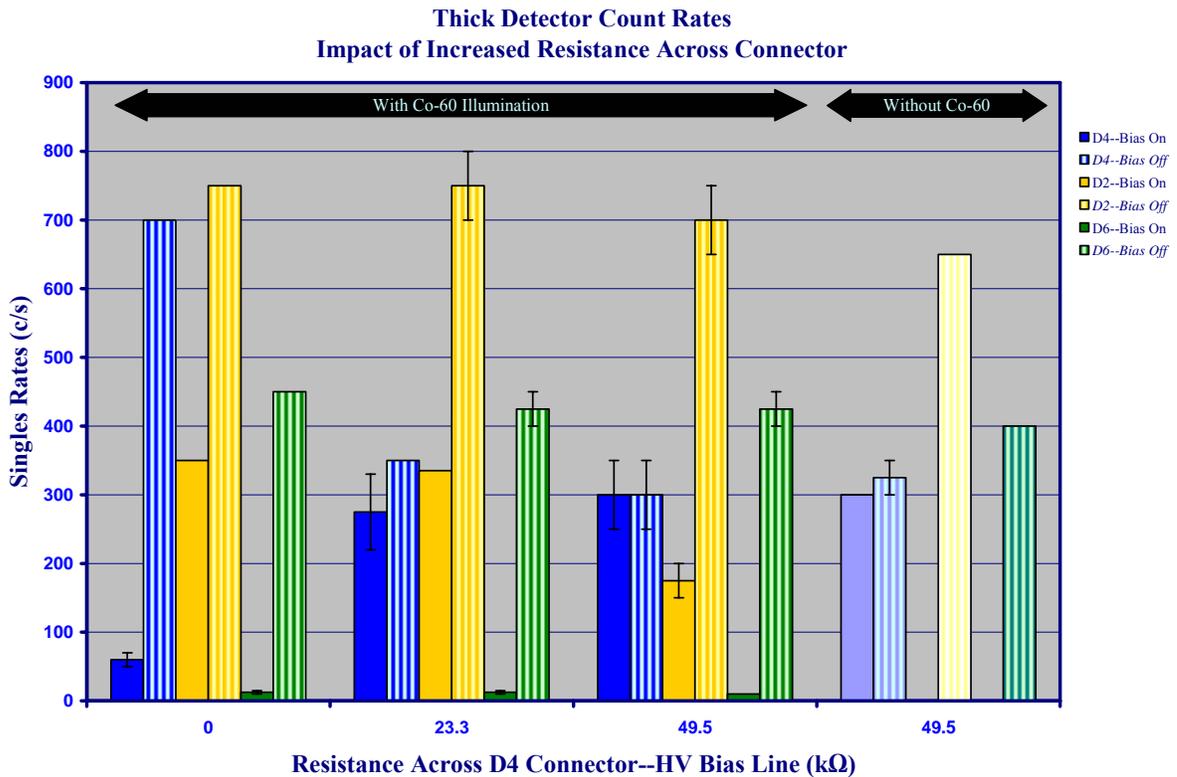
Singles rates were also measured at the 3 resistance settings with the bias on and off. It was found that the D4 singles rates behaved in a fashion similar to that observed during the flight model anomalous behavior. That is, with a resistance across the connector, the D4 singles increased when the bias was switched on. Without resistance across the detector, singles rates behaved as expected (See Figure 5).

**FIGURE 5:** Singles rates for 3 thick detectors in various configurations on the EM. The left-most 3 columns were acquired with a Co-60 source on the zenith side of the telescope. There was a variable resistor across the D4 HV bias line connector.

With 0Ω across the connector, singles rates appear nominal (the singles rates are non-zero with the bias on due to the Co-60 source). Rates rise in all 3 detectors when the bias is turned off.

With resistance across the connector, we see a rise in D4 singles with the bias on, compared to the zero-resistance case.

With a resistance across the D4 connector and no source, D2 and D6 behave as expected (i.e. no singles counts with bias on, but elevated singles rates with bias off). On the other hand, D4 singles are very high with the bias on, but with the bias off, they do not increase appreciably.

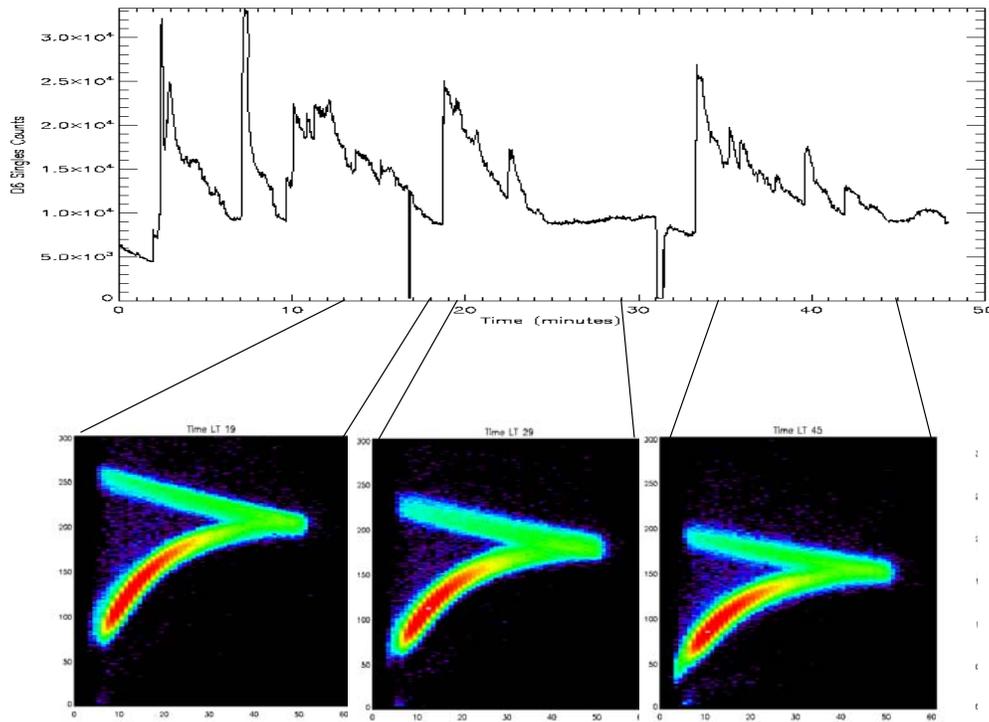
In the flight model, it was observed that the apparent gain in D2 changed over time. This feature has not been reproduced in the engineering model. The change in gain could be explained by some time-dependent electronic process(es) or a simple change in the resistance across the connector. It should be noted that the gain did appear to drift downward during a single data acquisition where there was no contact with the instrument (See Figure 6).

**FIGURE 6: Top Frame:** D6 singles rate as a function of time. This is indicative of the total beam rate that was being delivered to the instrument. Since the rate drifts down it must be adjusted up about every 10 minutes or so.

**Bottom Frames:** 2D histograms of D2 pulse-height vs. D1 pulse-height. In all cases the apparent gain of D2 is lower than expected. Each histogram was taken from data only between the indicated times. The apparent gain drifts steadily downward over the course of the run. The rate of the decrease has not been correlated with any other factors.
