# Recreating the CRaTER SN01 (FM2) D2 Anomaly with the Engineering Model

*Tony Case and Mike Golightly*  
*2007-11-13*

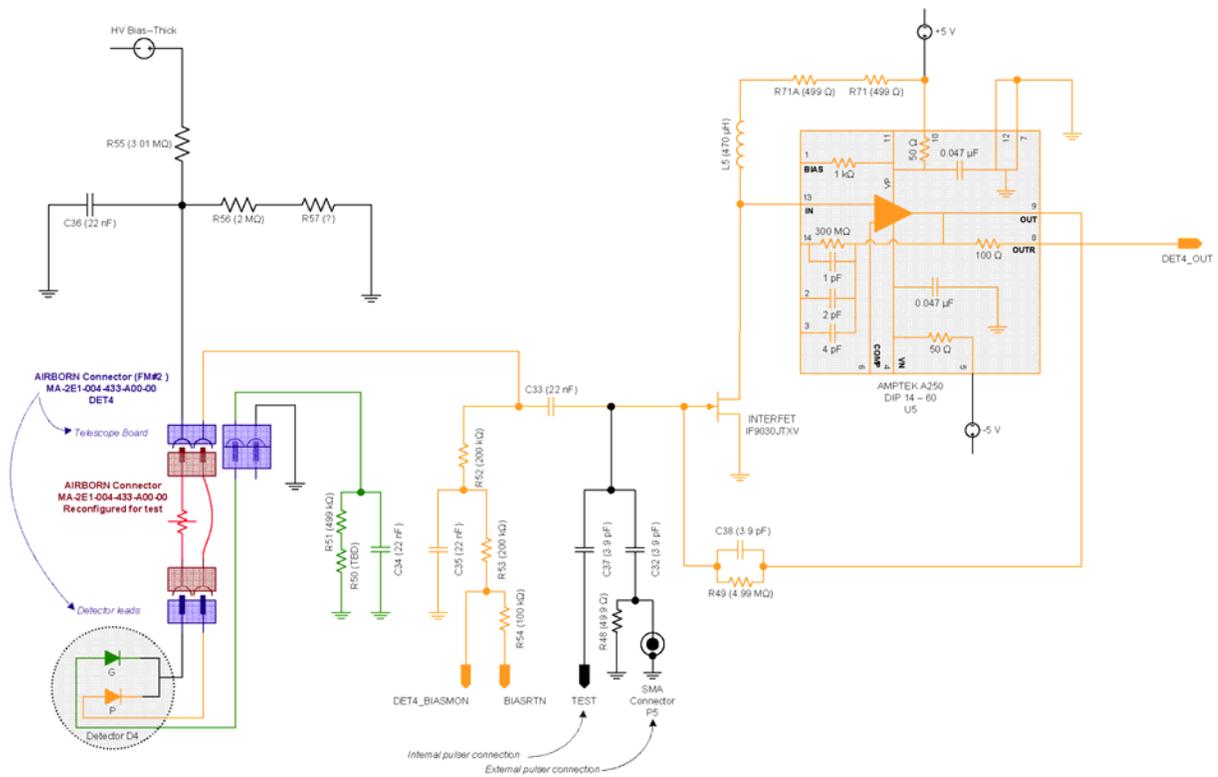
**FIGURE 3:** A schematic of the telescope board setup as used in testing.

chains and written to archive files via the normal Ballard Box-PC interface (See Images 2 and 3 and Figure 3).

Diagram adapted from drawing  
 "CRaTER TELESCOPE BOARD Thick Detector #4 Preamp"  
 (DWG # 32-03005 Rev 0, 10 May 2006, sheet 5 of 7)
